# EXPLORATORY DEVELOPMENT OF NEW AND IMPROVED SELF-SEALING MATERIALS FOR FUEL LINES

NORTHROP CORPORATION AIRCRAFT DIVISION HAWTHORNE, CALIFORNIA 90250

## OCTOBER 1974

FINAL REPORT COVERING PERIOD 26 FEBRUARY 1973 - 15 MARCH 1974

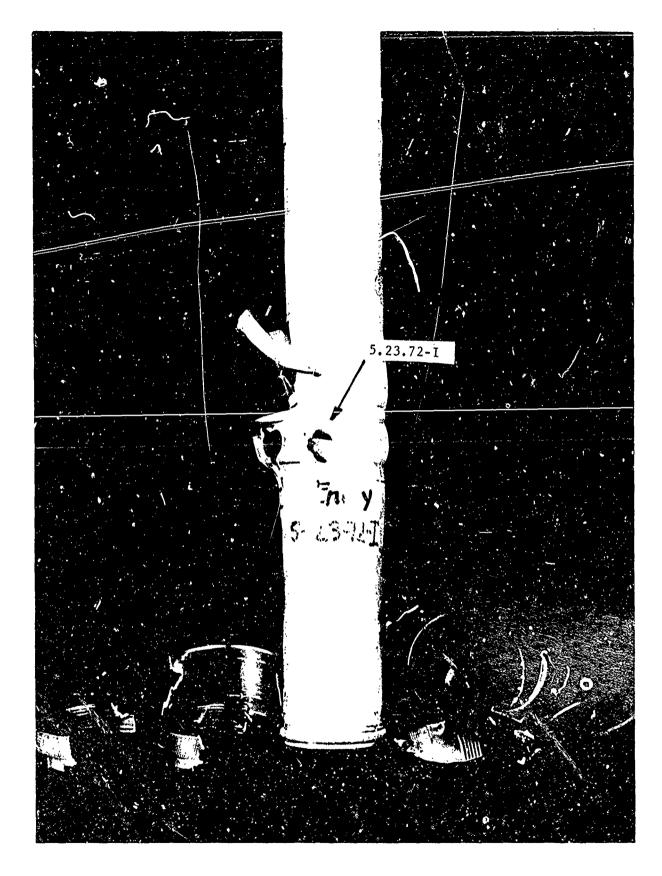
FIGURE 11. METAL FUEL LINE - BULLET HIT FITTING - ENTRY SIDE

_	۳.	1, ,	<u> </u>	- : : : : : : : : : : : : : : : : : : :			77
	REHÁRKS	The damage at the entry was a 3/8" dishole. At the exit; damage was heavy. (Figs. 9 6 16, Ling 5:18.72-1)	Damage at entry, was a vk" dia. hole & at exit damage was %" x 3/8" hole with a 1k" long crack across the hole. (Figs. 9 & 10, Line 5:19,72-1)	A 3/8" dia, hole with no cracks occurred at the entry. At the exit; the dange was a 3/8" hole with minor rupuiring around the hole. Leakage was heavy. (Figs. 9 & 10, Line 5.19.72-II)	Projectile left a ½" x ½" hole at entry & a ½" x 1½" hole with heavy outward flowering at extr. The fluid loss was heavy. (Figs. 9 % 10, Line 5:19.72-III)	Decage at entry, was.a. %" dis hole with 31kghr.cracking around hole At exit, damage ass a.l. x. 2%" (singshole with heavy outward. figeringthe fluid.loss was.hisavy. (Figs. 9 & 10, Line 5.22.?2-II)	Projectile penatiated fitting at entry & exited fitting at exit. This provoked heavy rupturing of line & fitting. (Figs. 11 & 12, Line 5.23.72-1)

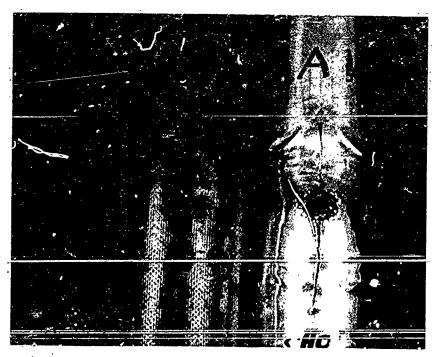
FIGURE 25. A1 UNPROTECTED LINE - A2 PROTECTED LINE - ENTRY SIDE

- At Line (Unprotected). At the entrance (see Figure 25) a 2-inch diameter hole occurred with outward and inward flowering. A 4-inch long longitudinal crack across the impact hole occurred. At the exit (see Figure 26) a 5/8-inch diameter hole was made by the exiting projectile. Only outward flowering occurred and a 3-inch long longitudinal crack across the hole occurred. The water flow pressure through the line dropped from 35 psi down to 12 psi.

- A2 Line (Protected). In comparison, this protected line showed very promising results. At the entry (Figure 25) and exit (Figure 26) pinhole size holes were noted. No apparent cracking or flowering of the laminated metal line occurred. The flexible laminate on the inside and outside did not show any tear damage. The water flow pressure dropped from 35 psi down to 32 psi only.

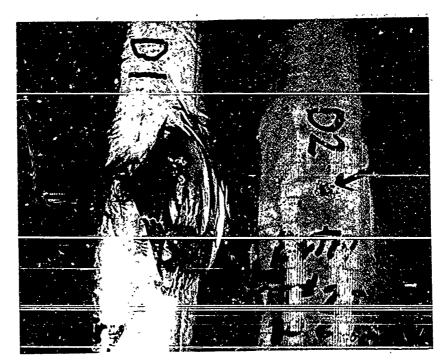
FIGURE 31. D1 UNPROTECTED LINE - D2 PROTECTED LINE - ENTRY SIDE

- $\underline{\text{D2 Line (Unprotected)}}$ . The damage was still severe (Figures 31 and 32) but not as bad as Bl above. The water flow pressure dropped from 35 psi down to 9 psi.

- <u>D2 Line (Protected)</u>. The damage was reduced drastically. A pinhole size hole occurred at the entrance (Figure 31) with no cracking or flowering of the laminated metal line. The exit (Figure 32) showed a 1-inch hole in the outside laminate with some outward flowering and possible small cracks in the laminated metal line. The laminate on the inside of the line showed a pinhole size hole. The water flow pressure dropped from 35 psi down to 25 psi.
